## RAPIDE AIRCRAFT TECHNICAL NEWS SHEET

### TECHNICAL NEWS SHEET SERIES CT(89) No 17 ISSUE 2

### FIRE PRECAUTIONS DURING ENGINE STARTING

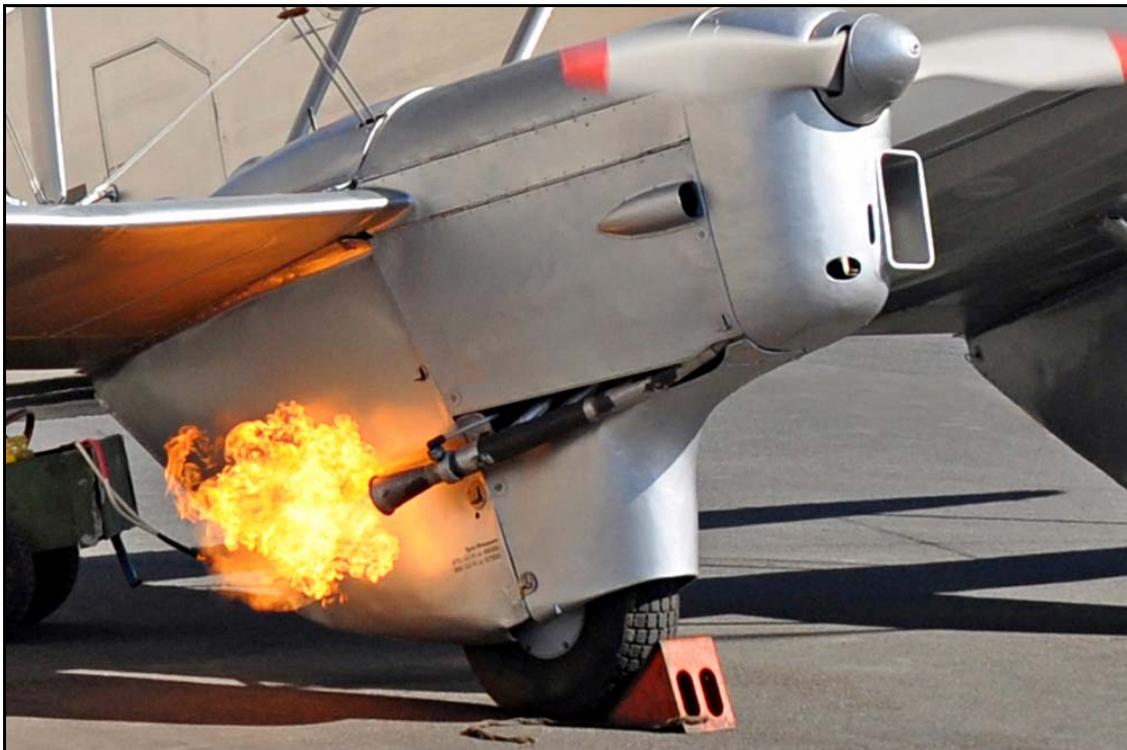
Empirical evidence suggests that this condition is most likely when an engine is restarted a short time after being stopped purely by turning off the ignition. It appears that the fuel content of the carburettor float chambers, already full and within the very hot engine bay, experiences expansion or boil-off which effectively self-primers the engine. This can be seen as a small overflow from the drains at the port side of each front trouser fairing. An engine start occurring prior to the dissipation of this unwanted 'prime' is prone to be over rich and with a consequent yellow exhaust flame. For this reason Reference C advised that carburetted Gipsy engines should be allowed to idle for a few minutes to cool, before turning off the fuel to run the carburettor entirely dry prior to switching off the magnetos in hot climatic conditions. [Similar advice is repeated as a standard end of flight procedure at Chapter III of the de Havilland Dragon Rapide Care and Maintenance Manual]

A secondary risk is that of igniting an explosive air/fuel mixture within the rear engine cowlings, due to spillage during refuelling or venting of a full tank when the fuel expands with temperature. Accumulated dry grass cuttings add obvious potential for combustion.
